# HONGQI EH7

Sedan, 5-seater, 4-doors, 2024-

Rescue Sheet\_HONGQI\_EH7\_01\_EN

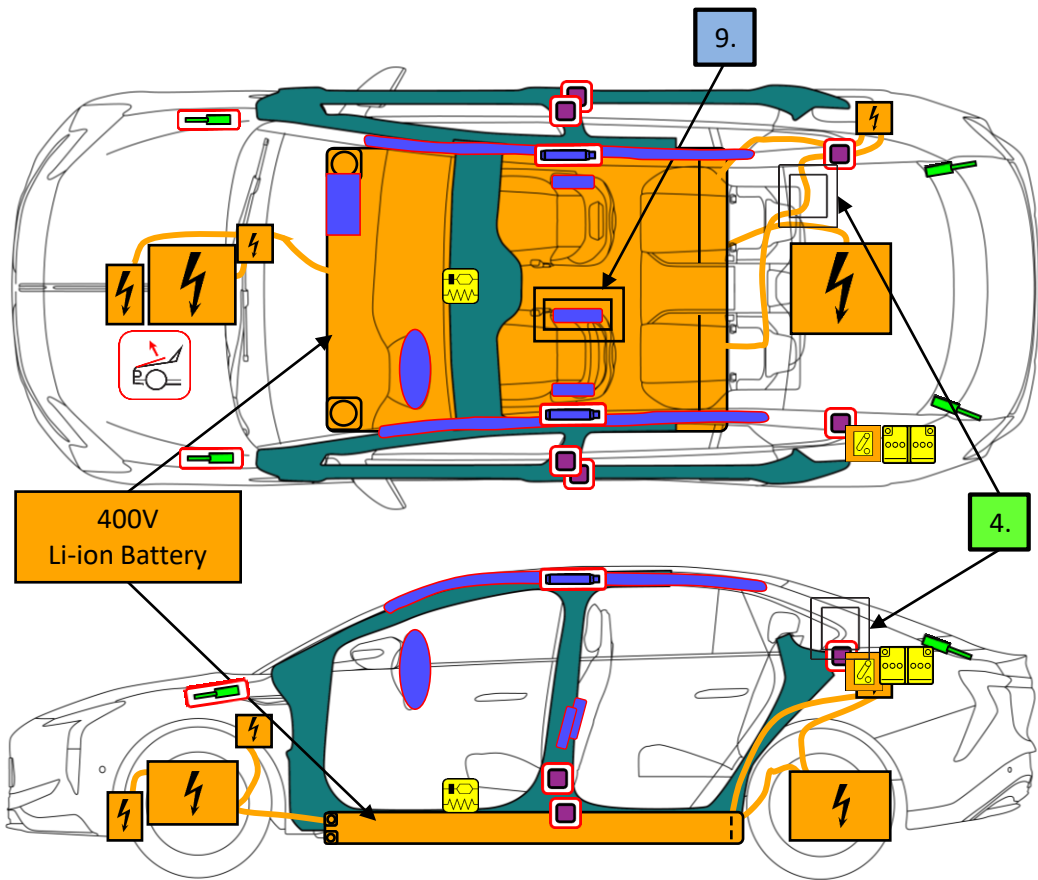
Driver's seat has a far side airbag in addition to the side airbag. Location of far side airbag is shown in the mark **9.** on Page 1.

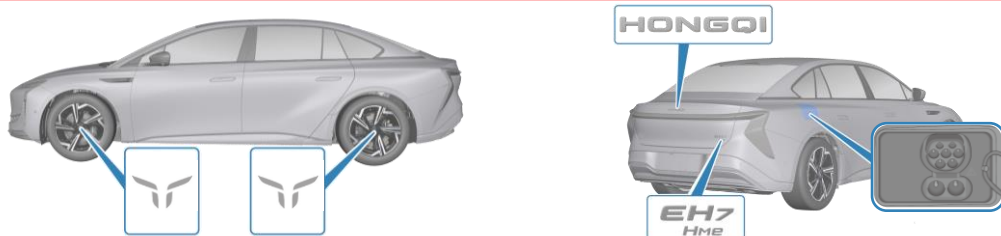
## 1. Identification / recognition

LACK OF ENGINE NOISE DOES NOT MEAN VEHICLE IS OFF. SILENT MOVEMENT OR INSTANT RESTART CAPABILITY EXISTS UNTIL VEHICLE IS SHUT DOWN. WEAR APPROPRIATE PPE.

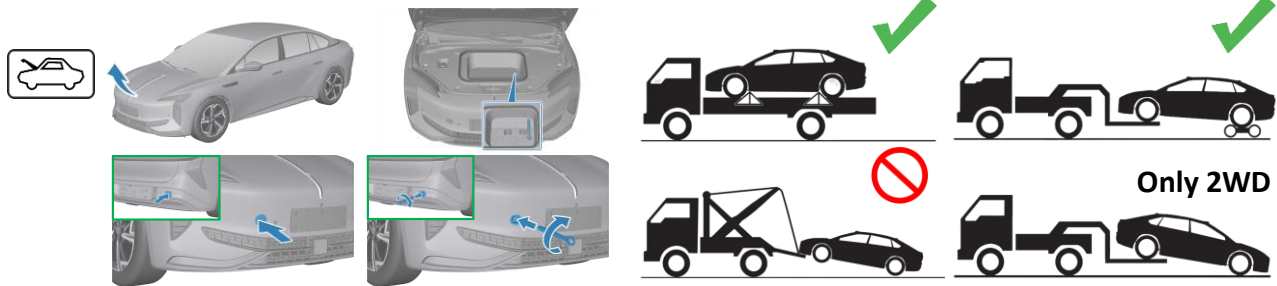
8. Towing / transportation / storage

Hook Front/Back

Store at a safe distance from other vehicles!

**BATTERY RE-IGNITION!**
